National Register of Historic Places
Continuation Sheet

Bates, John M. and Elizabeth, House
No. 4

Clackamas Co., OR

This is a Petition to delist the Bates House, No. 4 located at 4101 SW Southshore Drive, Lake Oswego, Oregon from the National Register of Historic Places. The residence is a single-story house on a daylight basement. It was designed in the 1950s and completed in 1954. The residence was listed on the register due to its architecture and engineering, including, closets, cabinetry, moldings and brass fittings. However, since that listing in 1990, those qualities (and details) have long ceased to exist.

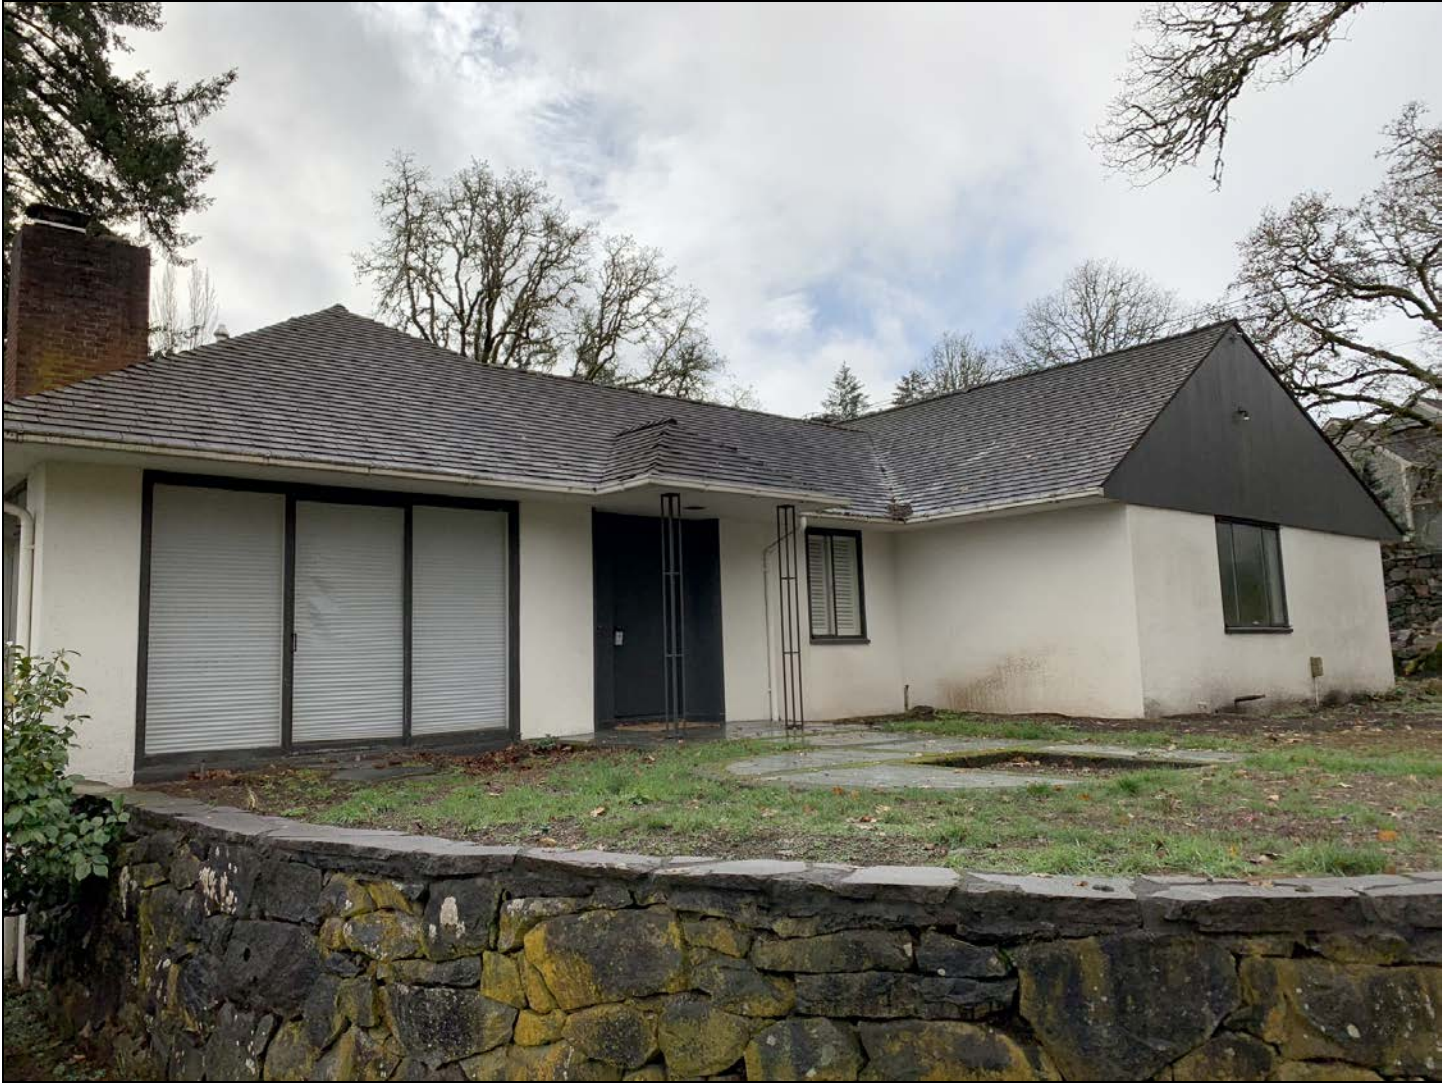
Photo 12 of 15: Missing landscape

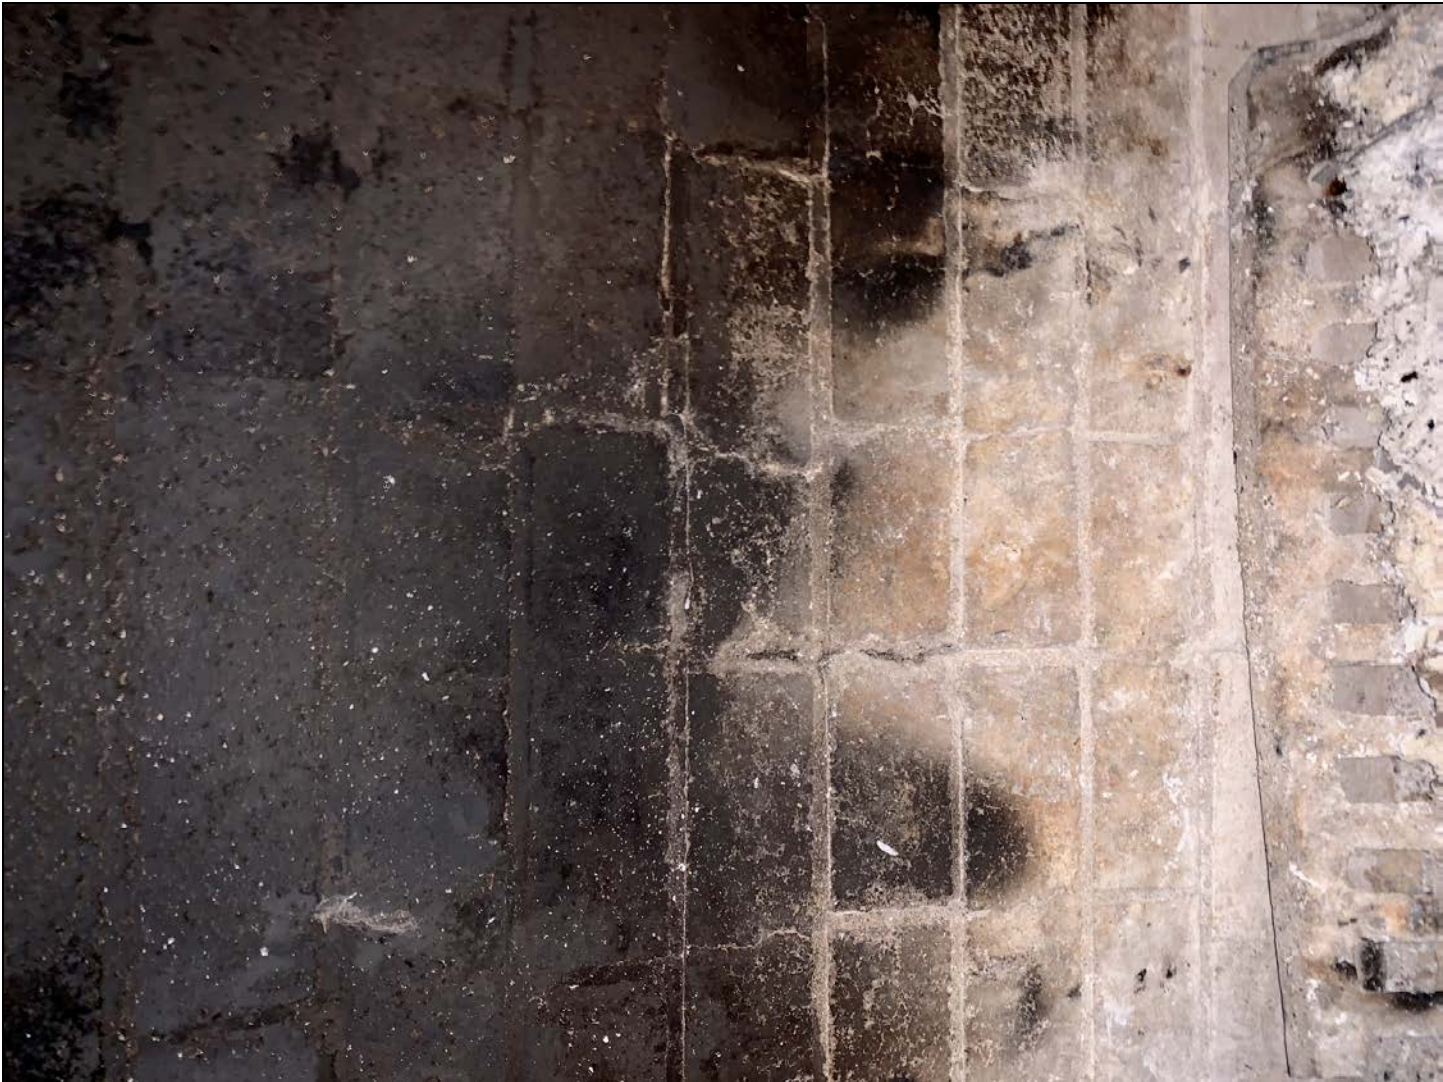
Photo 13 of 15: Destroyed/failing brick

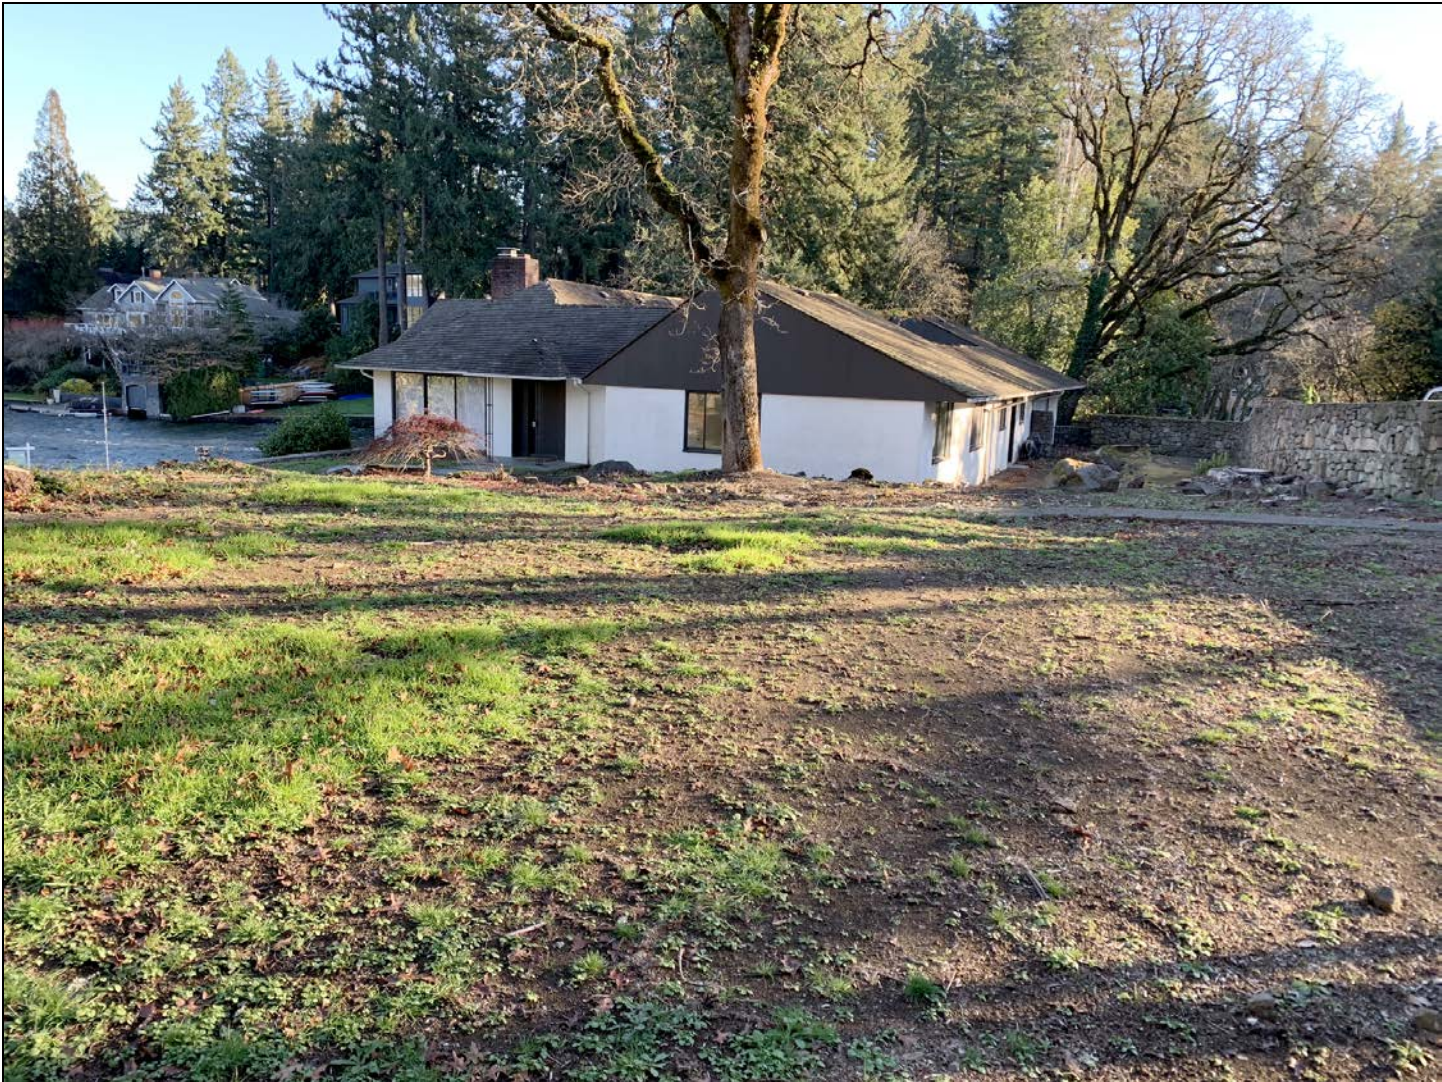
Photo 14 of 15: Missing landscape

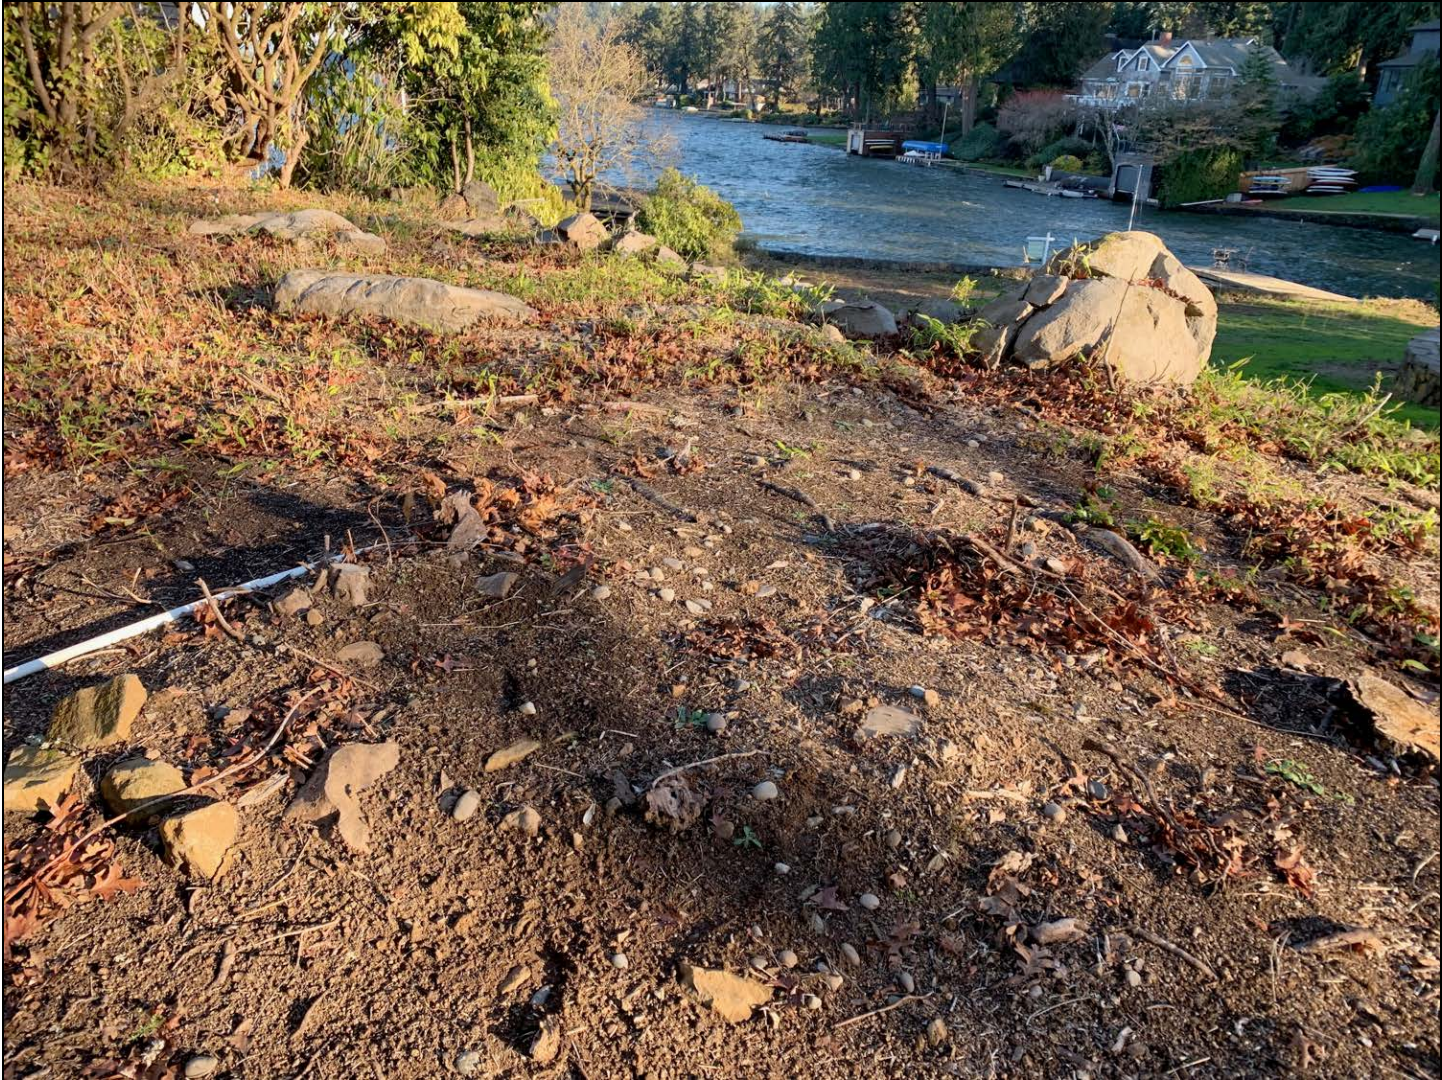
Photo 15 of 15: Missing landscape

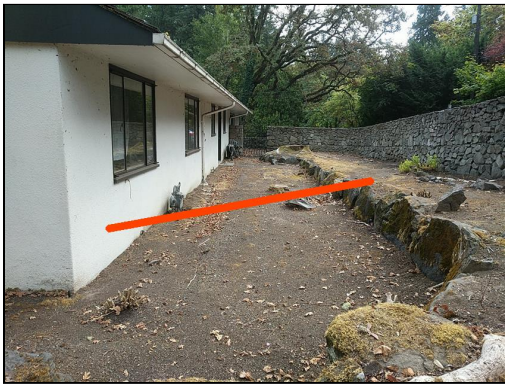
1.1 (2) There is a negative slope in the grading at the front of the home and left side of the home. This area does not appear to properly drain water away from the home and may need correction to the grading. A properly graded site should slope away from the home at least 6 inches within 10 feet of the foundation to help direct water away from the home. When it is not possible to achieve proper grading in this manner other measures may be used to promote proper drainage such as swales or landscaping drains. Recommend further evaluation and correction as needed by a qualified landscaping contractor.

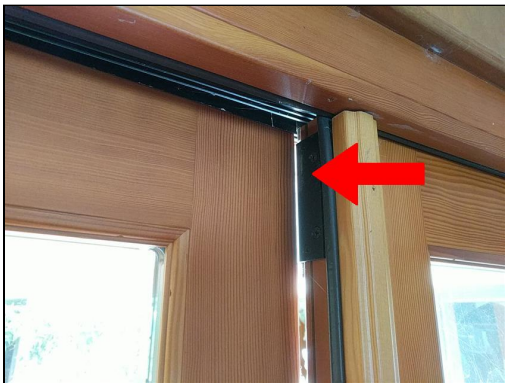
1.6 (2) Atrium doors were binding and would not fully close. This may be related to movement at this area from removal of posts (see notes at item 1.2). Recommend further evaluation and repairs as needed by a qualified contractor.

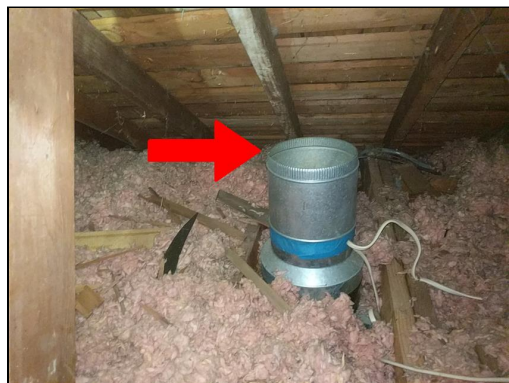
3.7 A bathroom exhaust vent terminated in the attic instead of at the home exterior. This can cause excessively high moisture vapor levels in the attic with the potential to damage home materials and be a source of microbial growth. Recommend correction by a qualified contractor.

The duct from the range hood or other exhaust system did not properly or fully direct exhaust to the exterior. This may result in moisture related damage to attic materials from the formation of condensation and is a potential source of microbial growth. Recommend correction by a qualified contractor so that the duct properly terminates to the exterior of the home.

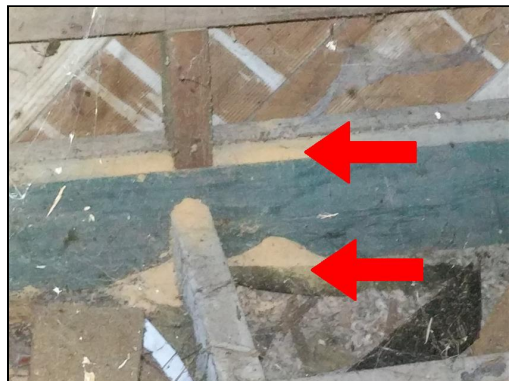
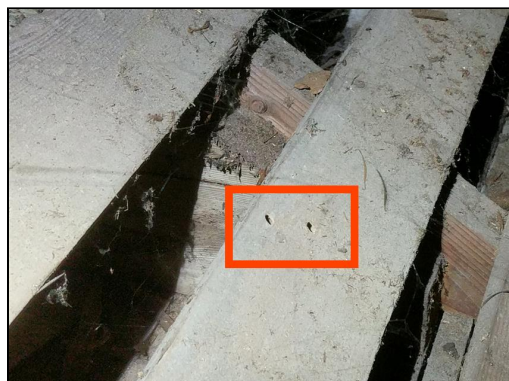
3.8 (1) Damage from wood destroying organisms (WDO's) was visible on the roof framing at one or more areas in the attic. What appeared to be fresh frass (powdery refuse from WDO activity) was visible indicating possible active WDO nesting exists. Recommend further evaluation by a qualified pest control expert and treatment for removal as advised.

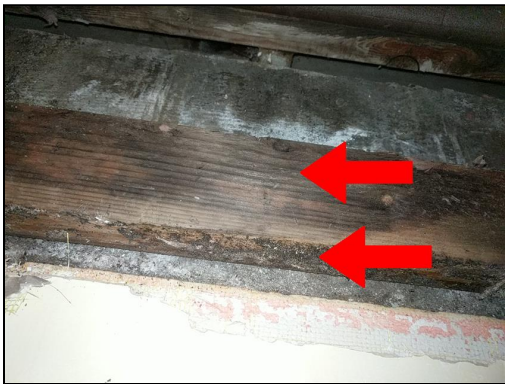
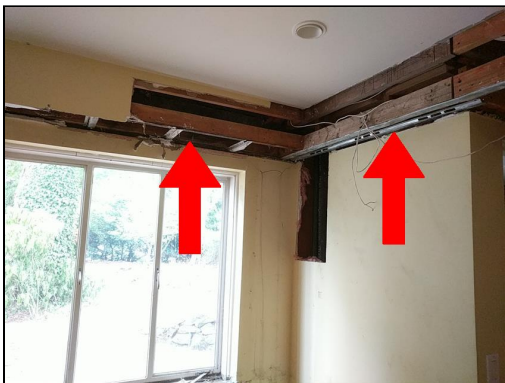
5.0.A (2) Exposed soffits had mold and wood rot visible. Recommend further evaluation and repairs as needed by a qualified contractor.

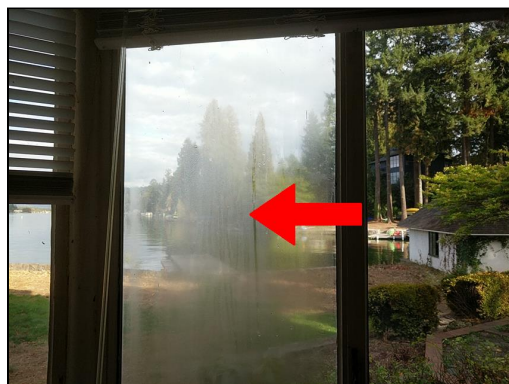
5.3.B (1) Condensation and / or stains visible in the glass of a double-pane window in the downstairs bedroom indicated a loss of thermal integrity and failure of the window seal. Recommend consulting with a qualified contractor to discuss options and costs for replacement.

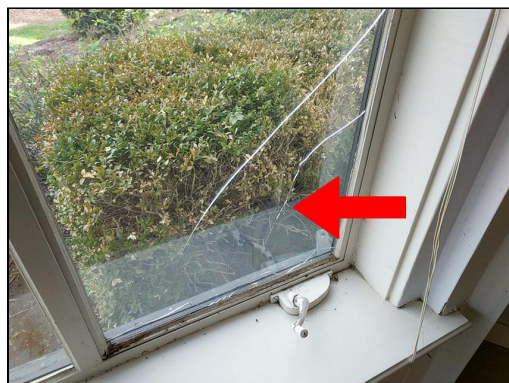
5.3.B (2) The glazing (glass) at a window in the downstairs bedroom was cracked or broken and needed replacement. Recommend repairs by a qualified contractor.

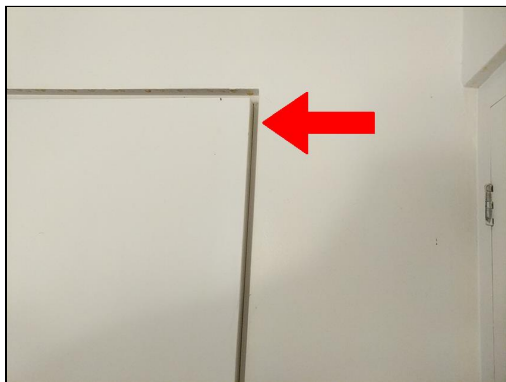
6.2 The door at the master bathroom was binding at the door jamb and did not properly open/ close and needed adjustment. Recommend correction by a qualified contractor.

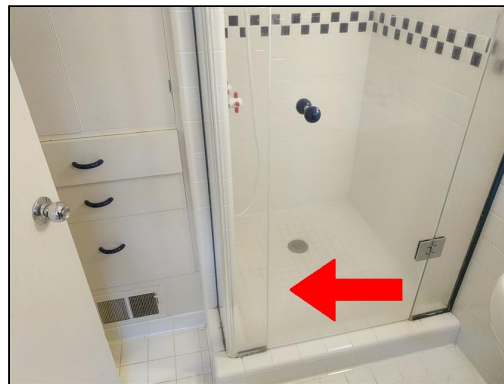
6.9 (2) The shower door was binding in the master bathroom and needed adjustment. Recommend repairs by a qualified contractor.

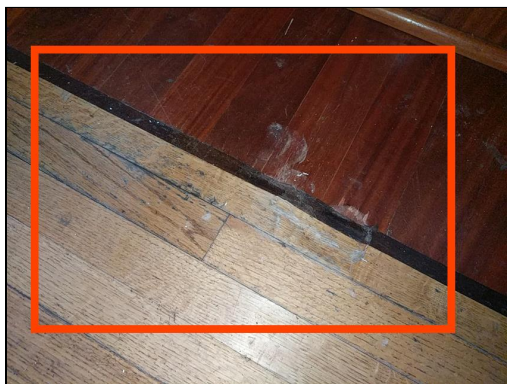
7.1 Kitchen floors had extensive water damage and will need replacement. Recommend consulting with a qualified flooring contractor for options and costs for repairs or replacement.

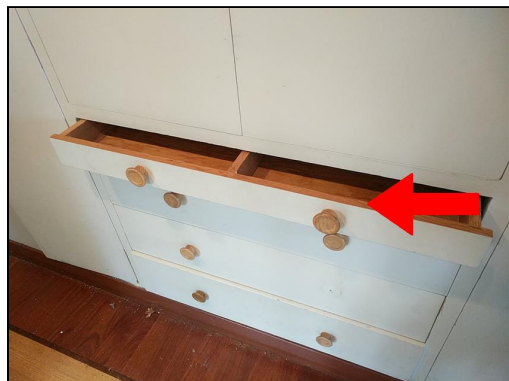
7.6 Multiple cabinet drawers and doors were binding and inoperable. Recommend further evaluation and repairs as needed by a qualified contractor.

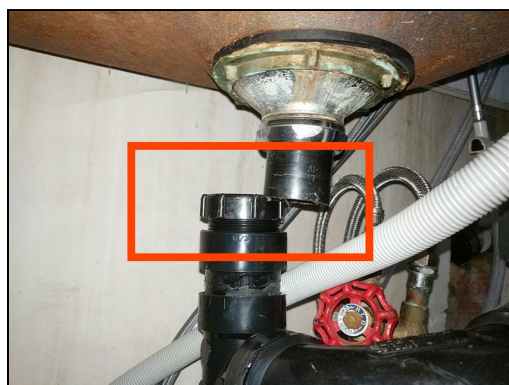
7.7 (1) The p-trap assembly at the kitchen sink waste line was broken and leaking. Recommend further evaluation and repairs by a qualified plumbing contractor.

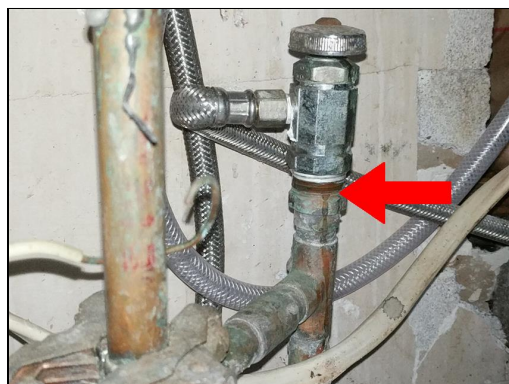
7.7 (2) The cold water shutoff valve was leaking below the kitchen sink. Recommend repairs by a qualified plumbing contractor.

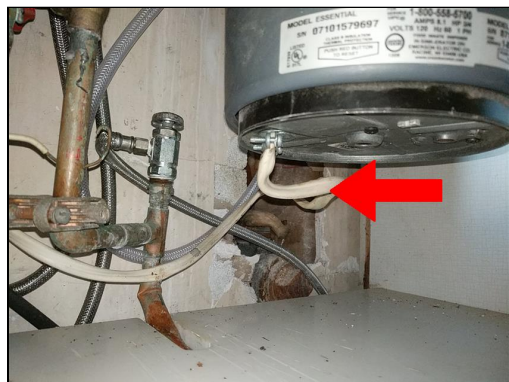
7.11 The electrical connection to the garbage disposal was improper at the time of the inspection. The disposal should either be powered by an approved appliance cord plugged into a dedicated outlet, or be hard-wired directly to a dedicated 20-amp circuit. Romex cable is not an approved type of appliance cord and should not be exposed outside of a wall cavity. Properly spliced connections should be housed within an appropriate junction box with a listed cover installed. The current configuration is a fire / shock / electrocution hazard. Recommend correction by a qualified electrical contractor.

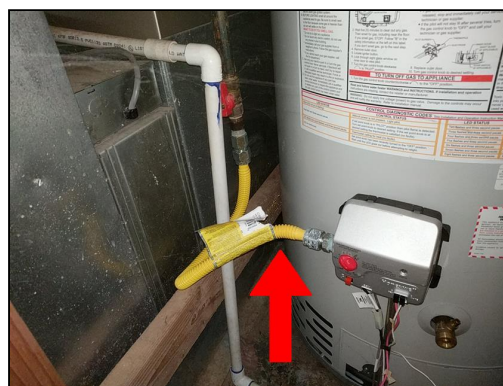
9.4 The water heater gas supply pipe had no drip leg or sediment trap installed. A drip leg is designed to prevent moisture and particulates from entering the gas valve and appliance, where they can interfere with gas supply and clog the orifices in the appliance. Recommend correction by a qualified plumber.

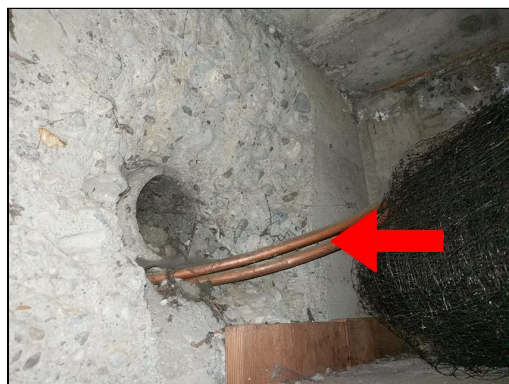
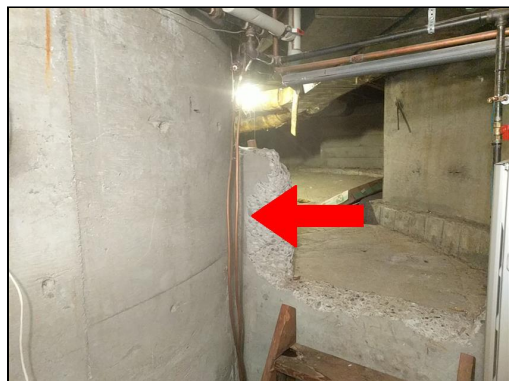
9.5 Evidence of the presence of an underground oil storage tank was visible at this home. Indications that an underground tank could be present may include vent pipes, refill pipes, an oil filter, and / or supply pipes. The tank was not inspected and the inspector disclaims the condition of the tank. Recommend asking the seller to provide any documentation about the decommissioning of the tank and whether it has been removed or not, or further evaluation by a tank scanning technician. More information about oil tank decommissioning and responsibilities can be found at the following [link](#).

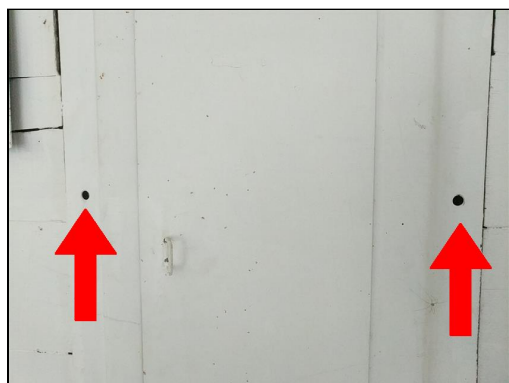
10.2 (1) The main distribution panel cover was missing one or more panel cover screws. Panel covers should be securely attached with all screws in place. Recommend replacement of the missing screw(s) with proper panel cover screws by a qualified electrician.

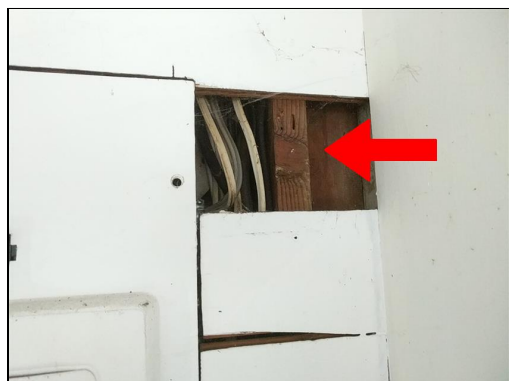
10.2 (2) Gaps around the edge of the panel cover were visible which leave energized electrical components exposed to touch and is a fire and safety hazard. No gaps larger than 1/8 of an inch should be visible around the panel cover. Recommend correction by a qualified electrician.

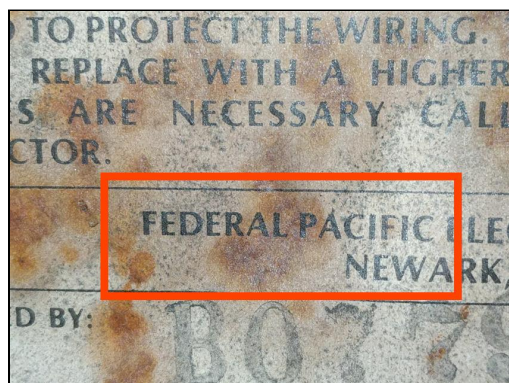
10.2

highly recommended that all Federal Pacific panels be replaced. Recommend consulting with a licensed electrical contractor for further evaluation and to discuss options and costs for upgrading the electrical panel.

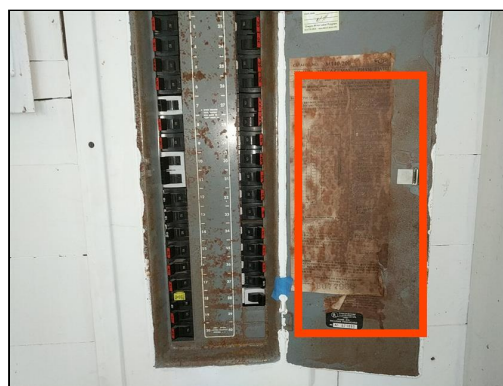
10.2 (4) A 'Circuit Directory' label at the main distribution panel identifying individual electrical circuits was incomplete, confusing, or appeared to be outdated. The service panel should contain a clearly-marked label identifying the individual circuits so that in an emergency, individual circuits can be quickly identified and shut off. Recommend that a properly marked circuit directory label be installed by a qualified electrical contractor.

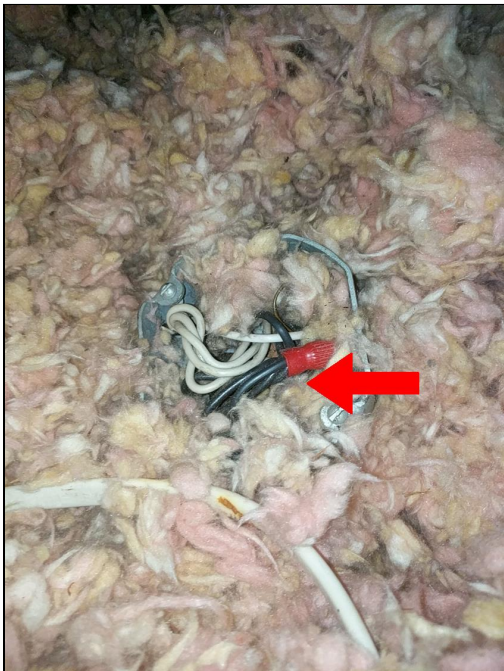
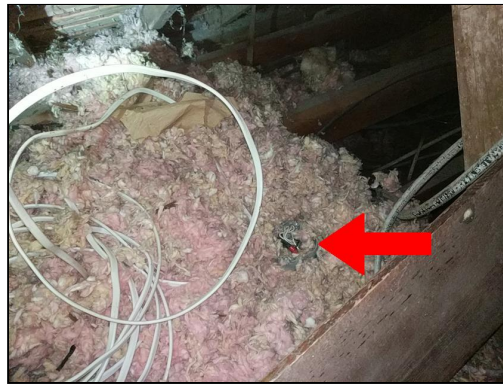
10.4 (3) A junction box installed at the attic was missing a junction box cover and energized electrical components were exposed to touch. This is a fire/ electrical shock/ electrocution hazard. All junction boxes should be covered by a listed junction box cover. Recommend correction by a qualified electrician.

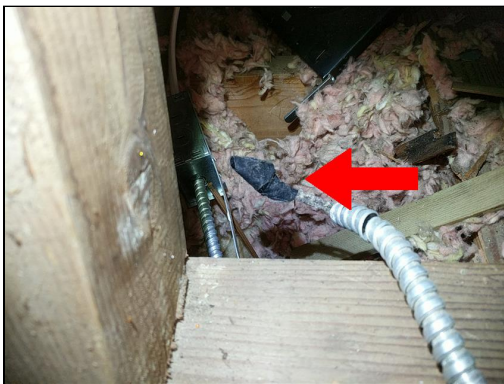
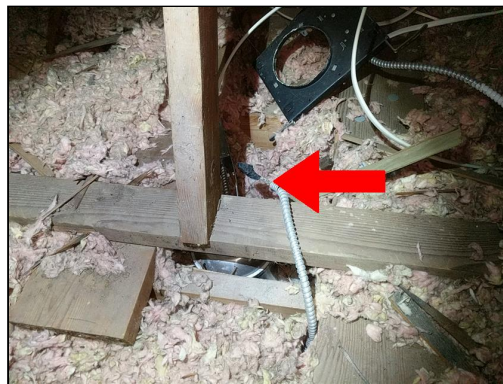
10.4 (4) Energized electrical wires were visible in the attic which terminated outside of a junction box and is a potential fire hazard and shock/ electrocution hazard. All wire terminations should be terminated inside of an approved junction box with a listed cover. Recommend further evaluation and correction as needed by a qualified electrical contractor.

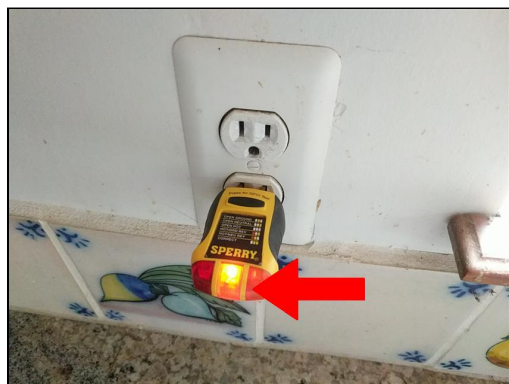
10.5 One or more electrical receptacles in the kitchen had an open ground. Other receptacles in the home were grounded, which indicates a potential wiring deficiency at the ungrounded receptacle(s). Recommend further evaluation and correction by a qualified electrical contractor.

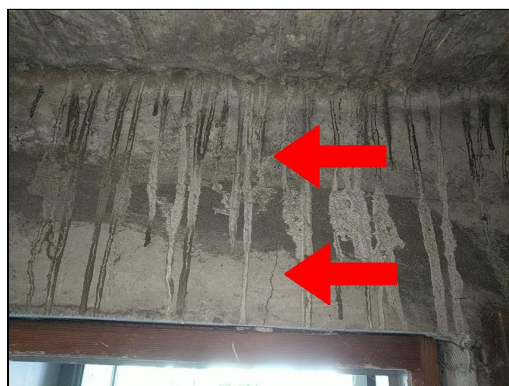
13.1 Cracks of varying width were visible at multiple areas in the foundation walls which appeared to be the result of settling and soil movement. Recommend further review and/ or repairs by a qualified structural engineer.

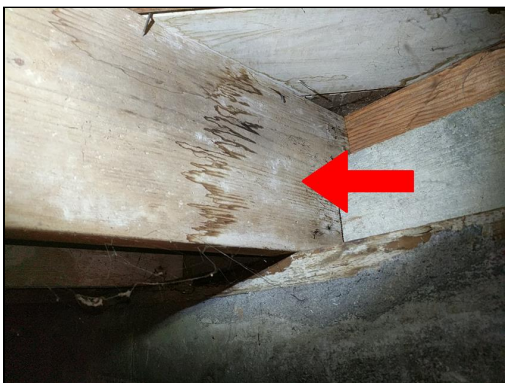
13.3 (2) Water staining was visible at multiple floor joist ends at the east and north sides of the home. This may be the result of a negative grade in the slope at this area (see notes at item 1.1) which is allowing excessive moisture contact with the home. Recommend further evaluation and repairs as needed by a qualified contractor.

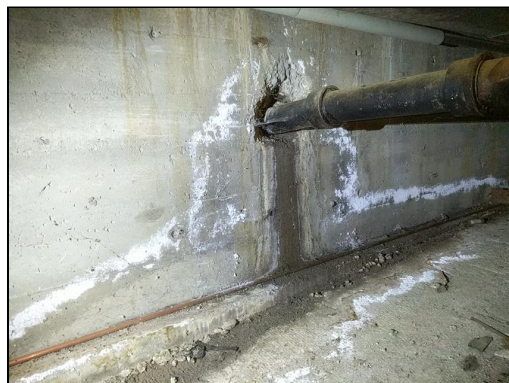
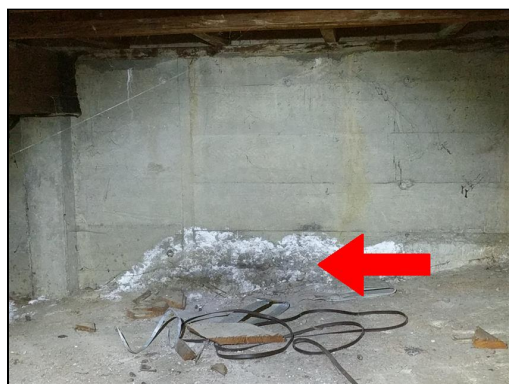
13.8 (1) Efflorescence deposits were visible at multiple interior surfaces of the foundation walls in the crawlspace. Efflorescence is a white, powdery residue left by moisture wicking through the foundation wall and its presence indicates high moisture levels in soil near the foundation. Excessively high moisture levels in soil supporting the foundation can cause various structural problems related to soil movement. Improvements to the grading and drainage around the exterior of the home will likely help improve conditions related to moisture against the foundation walls. Small amounts of efflorescence is not a cause for concern but should be monitored; if this condition appears to worsen over time, steps should be taken to improve grading and drainage.
